# BELZONA REPAIR TO FERRY'S PROPULSION SYSTEM

ID: 3159

Voith Schneider propulsion unit of a ferry.

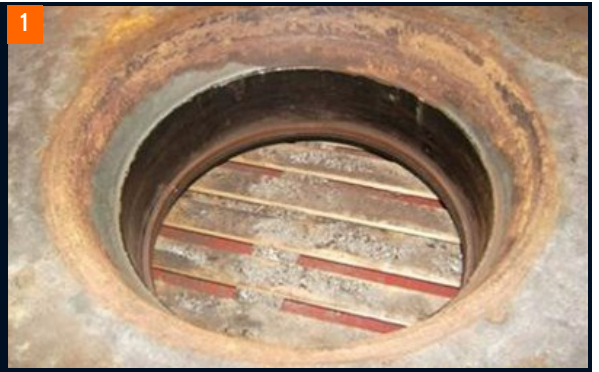
Erosion-corrosion on the face and bore of the casing, due to sea water corrosion and erosion from entrained sand. If allowed to continue the casing could be perforated leading to oil leakage.

1. Close view of the erosion-corrosion problem
2. Eroded areas rebuilt with Belzona 1311
3. Application of a final blue coat of Belzona 1341 to protect the casing against further erosion-corrosion problems
4. 2009 application - Belzona 1341 applied on the casing

Application was carried out in accordance with Belzona Know-How System Leaflets SOS-1 and SOS-2. Pitted areas were rebuilt with Belzona® 1311 before receiving 2 coats Belzona® 1341 for overall erosion-corrosion protection.
