# BELZONA SAVES SEVERAL WEEKS OF DOWNTIME

ID: 316

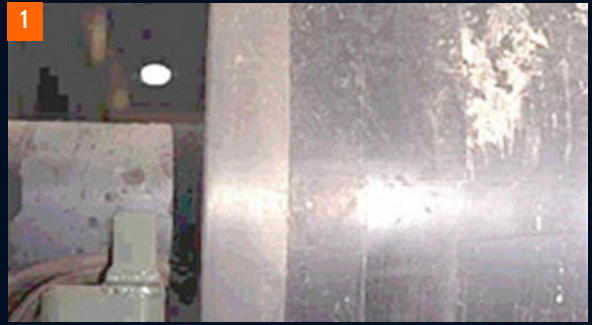
The rubber lined felt rolls are damaged from continuous abrasive wear of the wires edge and underside. This eventually causes sheet stretching and/or wrinkling.

1. Final rectification of Belzona repair
2. Felt roll back in service

Putting a new rubber cover on a roll is very expensive and the roll is usually out of service for weeks. The hardness of the Belzona repair must be close to the hardness of the rubber. In this case Belzona® 1111 (Super Metal) is 89 Shore D, or a P&J hardness between 8 and 9.
