# BELZONA RESTORES THE PROPER SURFACE PROFILE TO A PRESS ROLL

ID: 318

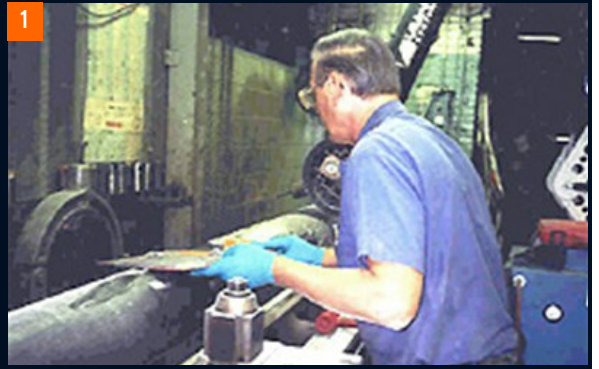
1. Applying Belzona 1111 (Super Metal) to damaged press roll
2. Removing excess Belzona from repair area
3. Machining repair to tolerances
4. Final rectification to maintain proper surface finish.

Belzona® 1111 (Super Metal) was used to repair the damaged surface of the press roll after a metal bolt had gone through the machine. The roll was then unable to remove water from the paper. This produced poor quality paper and resulted in breaks.
