# BELZONA PROVIDES LONG TERM PROTECTION FOR THIS TROUGH

ID: 319

Concrete clarifier trough

City of Boone Wastewater Treatment Facility, North Carolina, USA

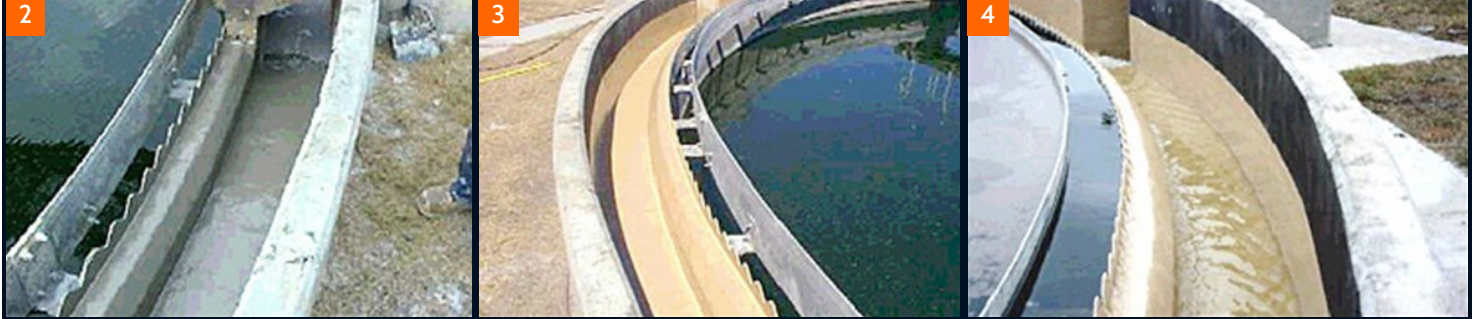
Previous elastomeric coating started to fail and algae built up and made it very difficult to clean. In addition, the concrete behind the lining began to deteriorate, as cracking and spalling of the substrate were evident.

1. Previously damaged elastomeric lining
2. Clarifier trough rebuilt with Belzona 4131 (Magma Screed)
3. Clarifier trough coated with Belzona 5811 (Immersion Grade)
4. Clarifier back in service.

The application was carried out in accordance with Belzona Know-How System Leaflets TCC-9 and TCC-15.

Belzona 4131 (Magma Screed)  
Belzona 5811 (Immersion Grade)
