# BELZONA REPAIRS AND ENHANCES CONCRETE CLARIFIER TROUGHS

ID: 320

80-ft diameter concrete clarifier trough.

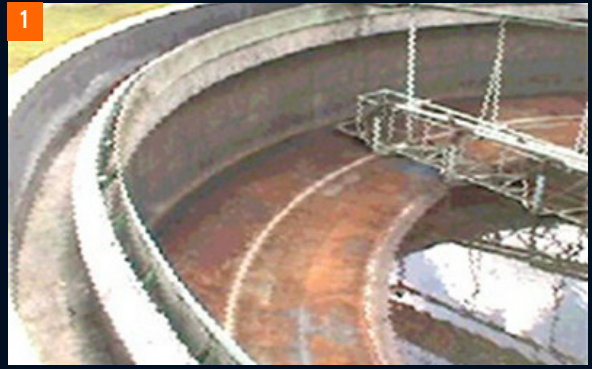
1. Clarifier drained to affect repairs
2. Concrete damage from failure of coal tar epoxy system
3. Application of second coat of Belzona 5811 (Immersion Grade)
4. Finished application.

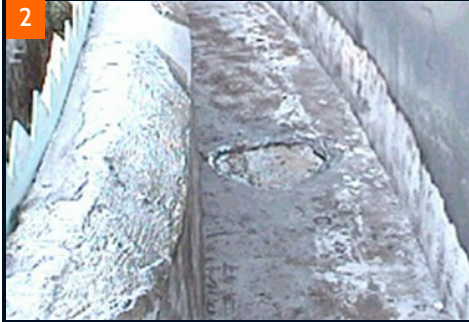
An old coal tar epoxy system had failed and resulted in damage to the underlying concrete. It also made it very difficult to keep the trough clean and free from algae buildup.
