# WORN FAN BLADES RESTORED WITH BELZONA

ID: 321

GRP fan blades from cooling towers.

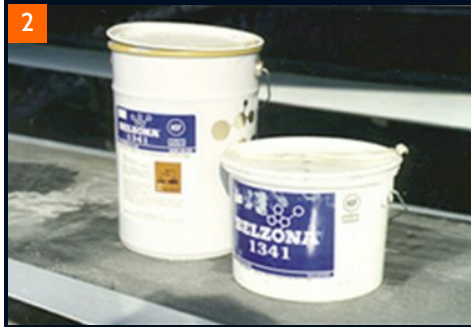
UV degradation, erosion and impingement had caused damage to the surface coating on the blades potentially leading to more porous damage.

1. Application of Belzona 4151 to the blades
2. Belzona 1341 applied to leading edges
3. Belzona 5111 applied by airless spray
4. Blades being returned for installation to cooling towers

Belzona® 4151 was used to repair the damaged top coat on the blades. Belzona® 1341 was used to protect the leading edges and Belzona® 5111 was used to provide overall protection. The Belzona refurbishment has avoided the high cost of blade replacement and provided the plant with long term protection of the blades.
