# BELZONA KEEPS CHEMICALS CONTAINED

ID: 322

Chemical containment floor of a sulfuric acid mixing station.

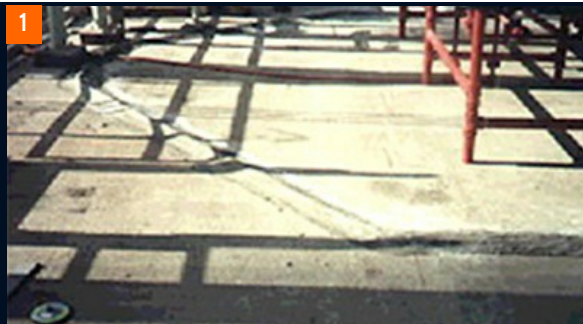
Sodium sulfate as well as some sulfuric acid is used to control the pH as well as sulfur content in the cooking liquor. This sulfuric acid mixing station suffered from acid deterioration and actually contaminated the paper making stock below.

1. Deteriorated sulfuric acid mixing station floor
2. First coat of Belzona 4311 (Magma CR1)
3. Finished application

The application was carried out in accordance with Belzona Know-How System Leaflet TCC-15. After pressure washing and neutralizing the containment area with soda ash, two coats of Belzona® 4311 (Magma CR1) was applied by brush and roller.
