# BELZONA FOR EMERGENCY LEAK SEALING

ID: 323

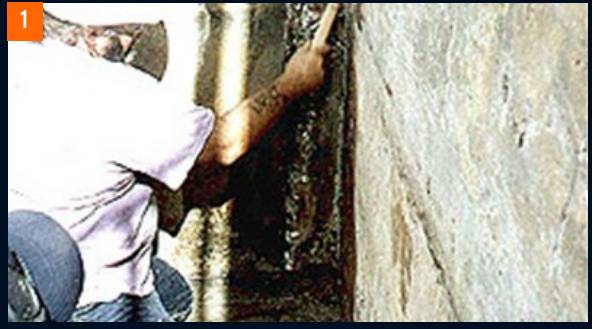
Leaking in the joint between a new, and existing tank. Loss of water estimated at one million gallons per month.

1. Cleaning away old concrete
2. The completed repair

This repair was carried out with a stream of water flowing out of the crack. Because of the anticipated movement in this joint, the repair was expected to be temporary. It did, in fact begin leaking some time later, but at a much reduced rate. When the tank is drained, a more permanent Belzona repair will be carried out.
