# BELZONA STOPS LEAKING IN CONCRETE JOINTS

ID: 324

Elevated water supply tower.

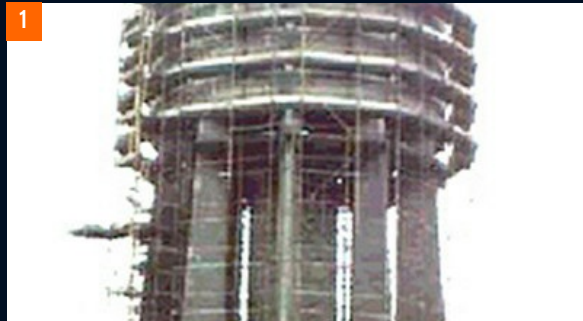
1. Water tower with access scaffolding in place
2. Typical leaking and staining
3. Completed application after second coat of Belzona 4211 (Magma Seal)

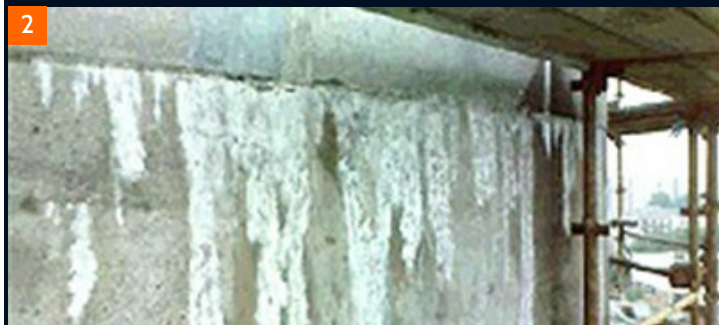
Water seepage was occurring at many of the joints in the cast concrete structure.

Joints were cleaned out thoroughly and Belzona® 4211 (Magma Stop) was used to seal obvious live leaks. Joints were then treated with two coats of Belzona® 4221 (Magma Seal) overlapping onto the surrounding concrete by approximately 12". Application was completed with no interruptions to water supply.
