# ABSORBER REPAIRED AND PROTECTED WITH BELZONA

ID: 3240

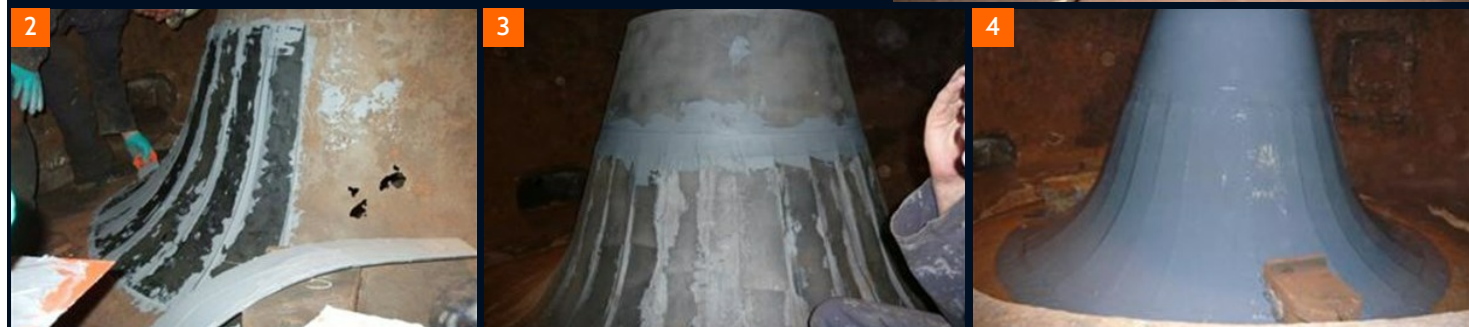
The bubbler throat on the absorber had developed a number of holes within the vessel compartment due to substrate erosion/corrosion.

Badly corroded throat area in absorber.

Absorber throat extensively damaged by corrosion. Steel plates being bonded onto the absorber using Belzona 1121. Cold bonding completed. Completed application with Belzona 1391 coating applied.

Application was carried out in accordance with Belzona Know-How System Leaflets TCC-1 & TCC-5. A total of 16 handleable sections of pre-formed mild steel plate were cold bonded to the substrate using Belzona® 1121 to completely encapsulate the affected areas. Once the Belzona had cured, the plates were frost blasted and the entire repair area was protected with Belzona® 1391 to prevent further damage.
