# BELZONA RESTORES POTABLE WATER SUPPLY TO CHINESE CITY

ID: 326

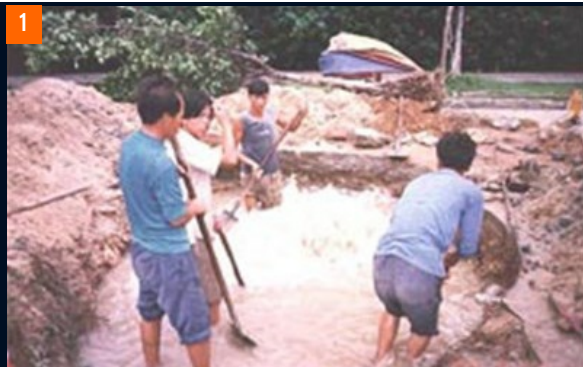
Routine construction above caused physical damage to this 1.2 meter diameter concrete pipeline carrying potable water to Guang Dong Province.

1. Pipe leaking large volumes of potable water
2. Pipe damage prepared for Belzona repair
3. Repair completed with Belzona 4111 (Magma Quartz)
