# BELZONA PERMANENTLY SECURES HANDRAIL POSTS

ID: 327

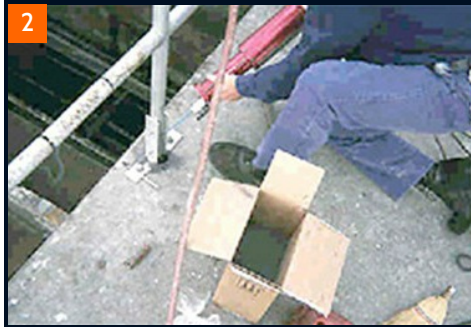
1. Removing loose debris from the handrail post/concrete interface
2. Injecting Belzona 4151 into the handrail post hole
3. Filling in the irregularity with the aggregate
4. Finished repair by mounding the resin to the shed water
