# FAN BLADE EDGES REBUILT WITH BELZONA

ID: 328

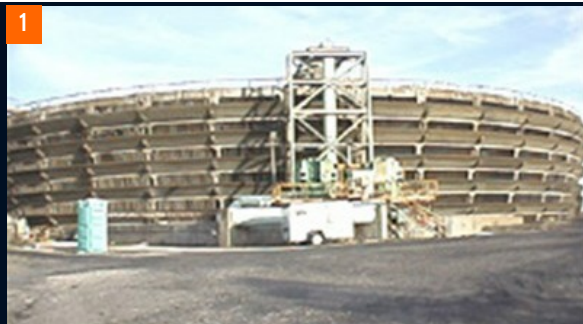
Erosion of both the leading and trailing edges of cooling tower fan blades, caused inefficient tower operation and raised concerns about blade replacement in the near future.

1. View of the huge cooling tower
2. Close-up of the fan blade damage
3. Application with small roller
4. Finished application

The application was carried out in accordance with Belzona Know-How System Leaflet FBC-1.

This huge cooling tower has ten individual cells. Each cell contains eight cooling tower blades, and all ten cells were refurbished with the aforementioned Belzona Know-How technique.
