# BELZONA REPAIRS SPALLED CONCRETE ON THIS AERATION TANK

ID: 329

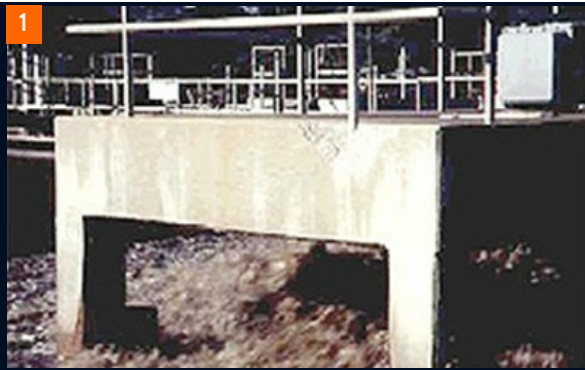
Deteriorated concrete around the base of the handrail posts raised safety concerns.

Spalled concrete at railings along a platform perimeter above an aeration tank.

1. Severely spalled concrete around handrail post
2. Repair of both sides and run at base of handrail post
3. Overall view of repaired deterioration

Patching the concrete did not work, since the old and new concrete did not bond well. This allows water to migrate through the repair, causing the same deterioration of the concrete as before. Replacing the slab would cost thousands of dollars as well as the interruption of the aeration tank process.
