# BELZONA ELIMINATES POTENTIAL SAFETY HAZARD

ID: 330

Spalled concrete at handrail post of a clarifier in a wastewater treatment plant.

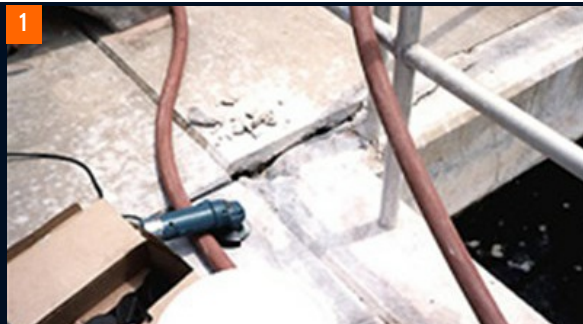
1. Severely spalled concrete adjacent to handrail post-surface preparation in progress
2. Repair at base of handrail post
3. Overall view of repaired area

The application was carried out in accordance with Belzona Know-How System Leaflet TCC-9.

Belzona 4131 (Magma Screed)
