# BELZONA REPAIRS A HOLE IN THIS HOPPER DREDGE HOSE

ID: 331

Hopper dredge hose.

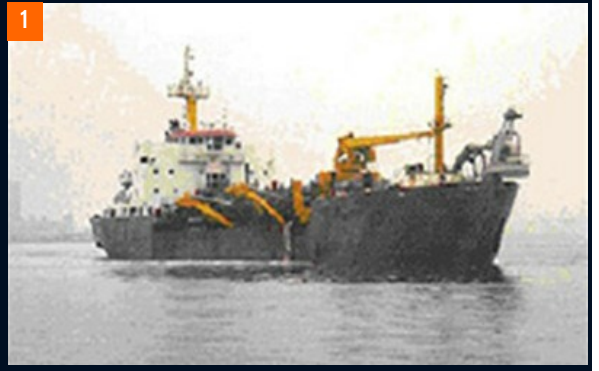
A hole in the hose was caused from large volumes of abrasive solids passing through it.

1. View of the Dutch dredge ship
2. Hopper dredge hose being inspected
3. Extensive damage evident
4. Area being rebuilt with Belzona 2311 (SR Elastomer)

Belzona 2111 (D&A Hi-Build)  
Belzona 2311 (SR Elastomer)
