# BELZONA SHAFT REPAIR AT STEEL MILL

ID: 3316

Worn shafts in steel rolling mill

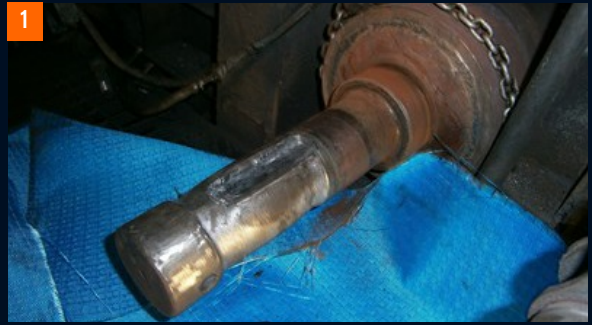
Heavy wear on the drive locations led to excessive downtime for the customer

1. Worn shaft prior to Belzona repair
2. Surface preparation carried out and the bottom former in place on the shaft
3. Former clamped in position and filled with Belzona 1111
4. Former removed revealing fully cured Belzona 1111 prior to dressing down

Application was carried out in accordance with Belzona Know-How System Leaflet MPT-2. After thorough surface preparation, the Belzona® 1111 was applied by brush to the repair area. Next, a pre-made split former was clamped over the repair and additional Belzona® 1111 was injected via ports. The material was allowed to cure fully before the former was removed and the repair dressed down before returning to service
