# SCRUBBER FILTER FRAMES REPAIRED PROTECTED WITH BELZONA

ID: 3317

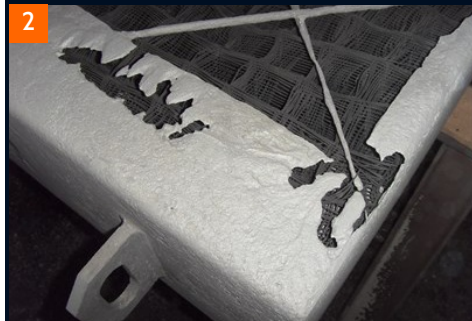
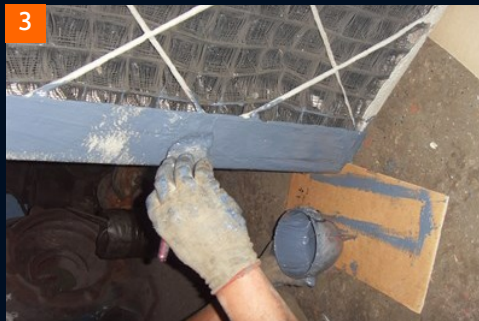
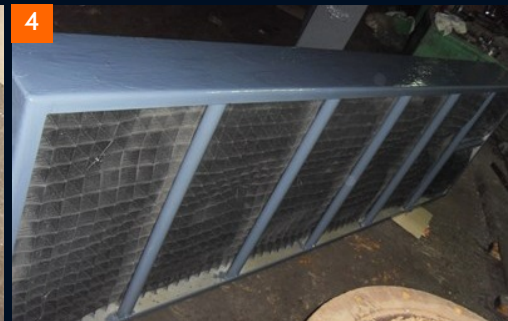
The environment contains up to 2,6 mg/Nm<sup>3</sup> phosphoric acid which leads to severe corrosion problems.

Scrubber filter frame before the application  
Filter frame gritblasted  
Application in progress  
Application to one of the scrubber filter frames completed.

The application was carried out in accordance with Belzona Know-How System Leaflet TCC-5. For the coating application, the standards DIN 28051, 28053 and 55128 were applied. Before the application, the surfaces were gritblasted to a minimum depth of profile of 75 microns.

The customer already knew Belzona and wanted to protect his filters with Belzona® 1321 which has the required acid and erosion resistance. The filters were repaired and protected in just three days which met the clients tight schedule.
