# VACUUM PUMP RESTORED WITH BELZONA

Liquid ring vacuum pump used in metal processing

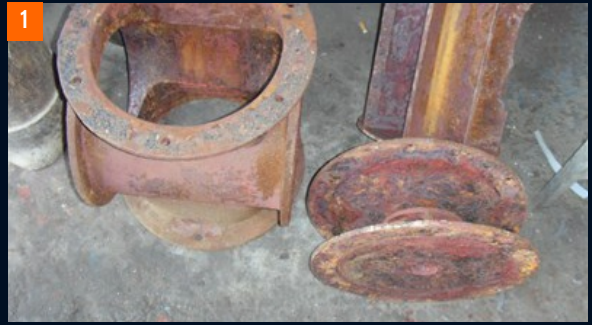
Corrosive fumes had caused severe corrosion on all parts of this vacuum pump.

1. Original stator and end covers
2. Original rotor
3. Completed application on the stator
4. Completed application on the rotor
