# PIPING DISTRIBUTION HEADER REPAIRED WITH BELZONA

ID: 335

Sludge water piping distribution header.

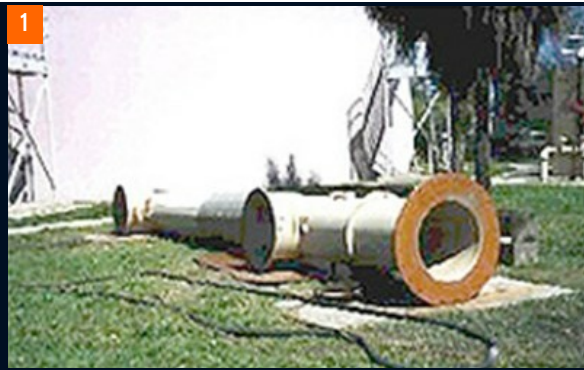
Corrosion as well as erosion deteriorated the entire internal surface of this sludge water piping structure. This pipework transports sludge water from the sedimentation tanks to the digester.

1. View of the sedimentation tanks
2. Repairs to pits with Belzona 1111 (Super Metal)
3. First coat Belzona 5811 (Immersion Grade)
4. Second coat of Belzona 5811 (Immersion Grade) almost complete

The application was carried out in accordance with Belzona Know-How System Leaflets VPF-1 and VPF-2.

Belzona 1111 (Super Metal)  
Belzona 5811 (Immersion Grade)
