# EXHAUST MIXER CORROSION PROBLEM SOLVED WITH BELZONA

ID: 336

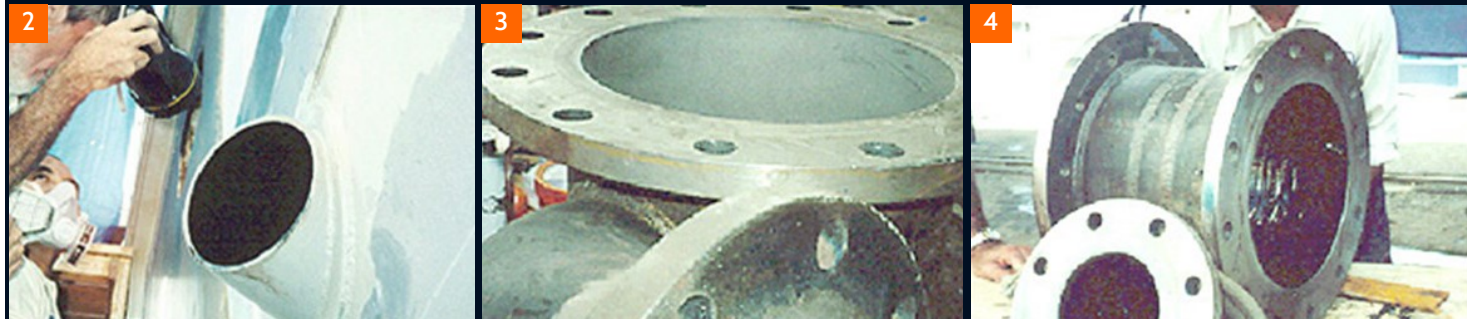
The original mixers suffered from corrosion from a combination of low concentrations of sulfuric acid and salt water. They needed to be replaced. The owner decided to coat his new mixers with Belzona® 1591 to prevent the situation from occurring again.

1. View of yacht
2. Exhaust Tru-hulls during surface preparation
3. Entire exhaust mixer grit blasted
4. Completed application with Belzona 1591

The application was carried out in accordance with Belzona Know-How System Leaflet VPF-2.
