# BELZONA IS THE IDEAL SOLUTION FOR WEAR RING REBUILDS

ID: 339

Wear ring seats of a centrifugal pump.

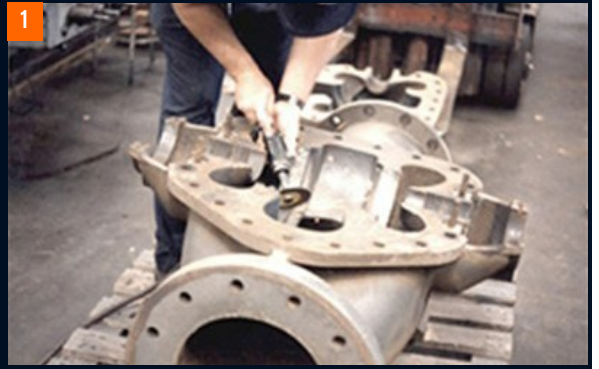
The wear ring seat clearances have deteriorated from dissimilar metal corrosion and caused poor pump performance from loss of pump tolerances.

1. Surface preparation using a side grinder
2. Belzona 9411 (Release Agent) being applied to new wear rings
3. New seats formed with Belzona 1111 (Super Metal)

The reforming of wear ring seats is a standard repair procedure that does not use uncontrolled heat treatments or specialized machining techniques to achieve a proper fit. By eliminating galvanic effects, the working life of this pump has been dramatically extended.
