# BELZONA COATS PUMP BOWLS

ID: 34

Two main cooling water pump bowls

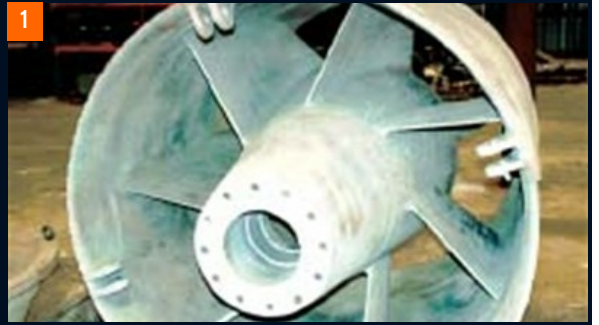
Corrosion damage to the housing; power plant wanted to increase the efficiency of the pump.

1. The impeller
2. Application of Belzona 1341 in progress
3. Two pump bowls coated
