# CHEMICAL ATTACK AND GALVANIC CORROSION STOPPED WITH BELZONA

ID: 340

Primary fan pump stuffing box.

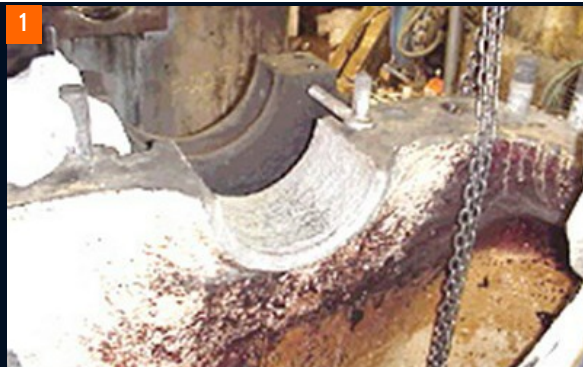
White water chemical attack, coupled with galvanic corrosion caused this large Goulds primary fan pump's stuffing box to deteriorate.

1. Damage stuffing box of large centrifugal pump
2. Galvanic damage to stuffing box shoulder
3. Rotating assembly dropped into the wet Belzona
4. Stuffing box completely rebuilt with Belzona 1111 (Super Metal)
