# BELZONA SOLVES CORROSION LEAKS ON TRANSFORMER LV TURRET

ID: 3409

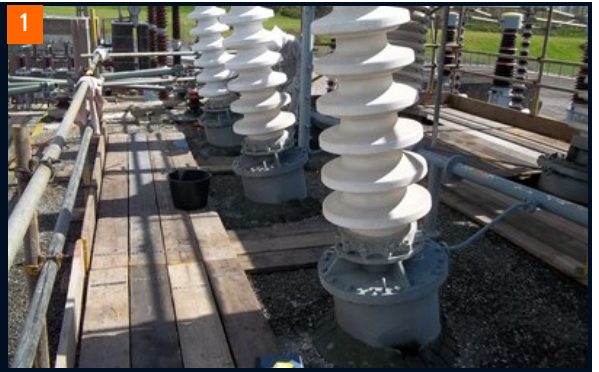
Corrosion and oil discharges were observed to the LV Turrets which indicated through wall penetration, placing the asset at high risk of internal contamination. Upon removing bituminous membrane, exposed metal corrosion and active oil discharges from Turret were identified.

1. Location of three LV Turrets
2. Corrosion and live leak oil discharge
3. Plate bonding
4. Work completed on one of the Turrets
