# BELZONA REPAIRS EBONITE LINING IN PROCESS VESSEL

ID: 3414

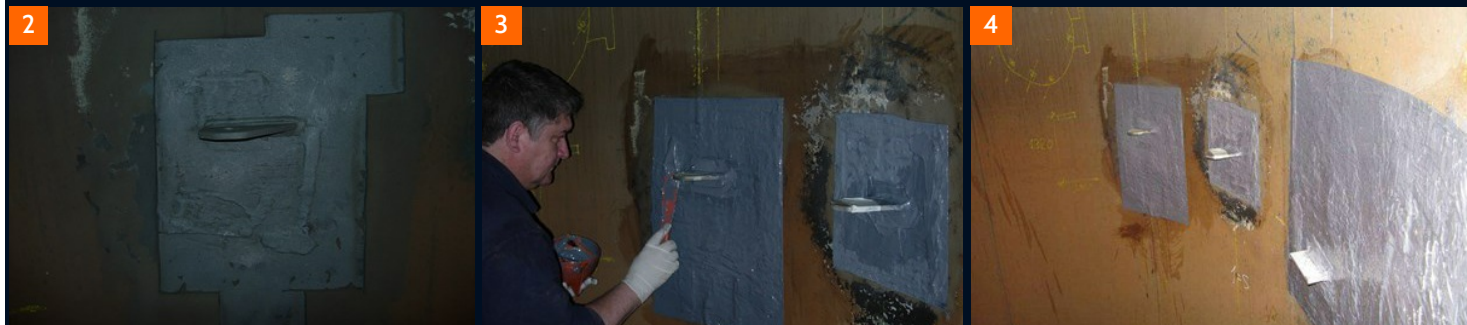
The internal ebonite lining was damaged around the vessel support areas where the ebonite had disbonded leaving the steel exposed.

1. Ebonite lining damaged around support areas
2. Surface preparation completed
3. Belzona 4301 being applied on the internal supports areas
4. Completed application

The application was carried out in accordance with Belzona Know-How System Leaflet TCC-3. The surface was prepared removing the previous mastic products. Then, the ebonite was roughened using a grinder and the whole application area was grit blasted to ensure a minimum 75 micron surface profile on the exposed steel before rebuilding all damaged areas with the Belzona® 4301.
