# BELZONA SEALS SPY GLASSES IN VESSEL

ID: 3415

Two spy glasses in process vessel (ion exchange).

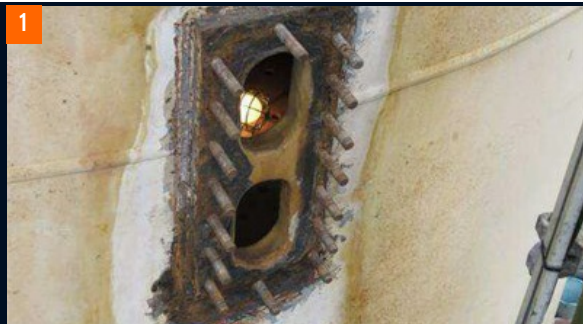
Corrosion had occurred at the spy glasses caused by the Hydrochloric acid used during the regeneration process.

1. Spy glass before the application
2. Grit blasting in progress
3. Surface preparation completed
4. Application completed
