# BELZONA SUPERWRAP WATER/CONDENSATE PIPE REPAIR

ID: 3416

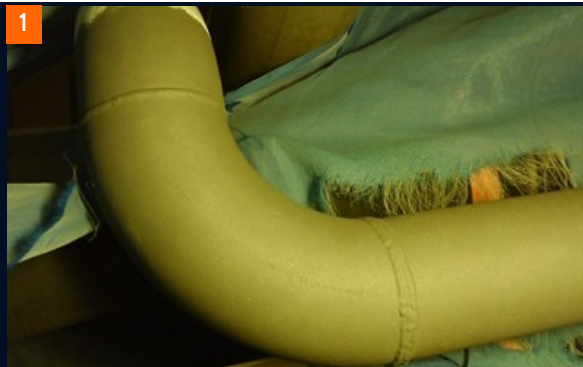
An area of the pipe system had lost 2/3 of its original wall thickness due to internal corrosion. The affected area was expected to go through-wall within the next 2-3 years. The client needed a compliant repair designed for a minimum of 5 years.

1. Grit blasted pipe prior to repair
2. Reinforcement spirals applied (9 in total)
3. Finished Application (Thickness 33mm, Length 540mm)

A Belzona® SuperWrap reinforced repair, compliant to ISO/TS24817 and ASME PCC-2 Article 4 was designed and applied by validated applicators.
