# BELZONA RELINES WATER PUMP

ID: 3417

Worthington pump used in water/waste water treatment.

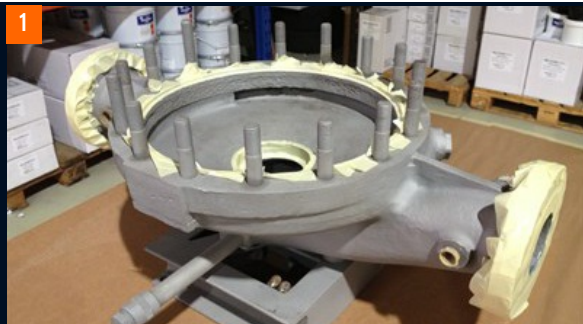
1. Grit blasted pump prior to application
2. Rebuilding internal damaged areas
3. Finished application
4. Pump and parts coated internal and external prior to return to client

The pump was suffering erosion/corrosion after 3 years in service due to total breakdown of existing unknown coating.

Application was carried out in accordance with Belzona Know-How System Leaflets CEP-3 & CEP-5.
