# INTERNAL COATING OF SEAWATER LIFT PUMPS

ID: 3418

Six new seawater lift pump chambers to be internally protected prior to assembly. The pumps are used for firefighting purposes on a North Sea platform.

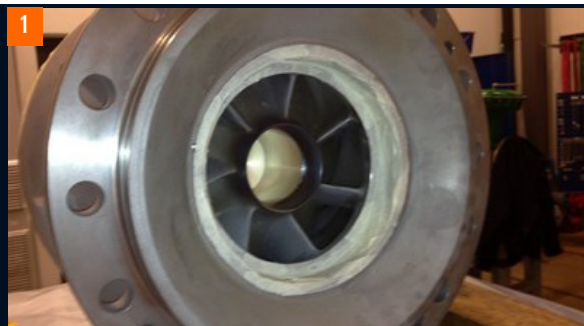
1. Grit blasted and prepared for coating
2. Internal coating ongoing
3. Internal coating completed
4. Overview of completed application prior to assembly

Application was carried out in accordance to the Belzona Know-How System Leaflet CEP-1. Following grit blasting, the pumps were coated with 2 layers of Belzona® 1321.
