# BELZONA PROTECTS NEWLY CONSTRUCTED PLANT ROOM

ID: 3419

Newly constructed plant room at the University.

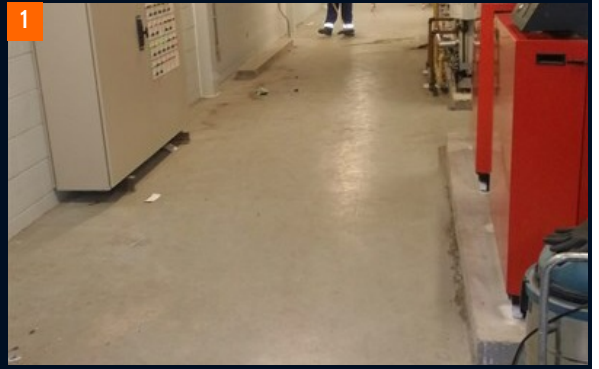
1. Clearing of plant room floor
2. Floor abraded in preparation for Belzona 4131 bund and fillets
3. Section of banded area
4. Completed plant room floor bund after coating with Belzona 5231

Application was carried out in accordance with Belzona System Leaflets FPA-3 and TCC-15. Belzona® 4131 was used to create raised banded areas and covings before applying Belzona® 5231 to completely seal the floor area.
