# EMERGENCY REPAIR OF TYRE AT QUARRY WITH BELZONA

ID: 3426

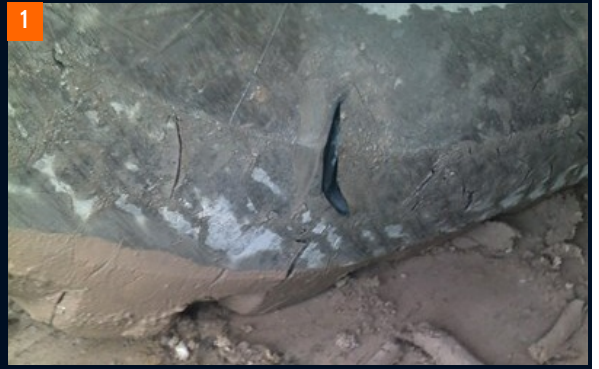
The tyre on the loader was damaged by sharp edged rock. Air was leaking when the crack was in bottom position under full load. Customer needed emergency repair so the loader could continue to operate until new tyres could be purchased and installed.

Damage in tyre 2 Damaged area prepared and conditioned with Belzona 2911 Embedding Belzona 9341 (Reinforcement Tape) into the crack  
Repaired tyre ready to operate
