# BELZONA REPAIR TO FRANCIS TURBINE END COVER

ID: 3427

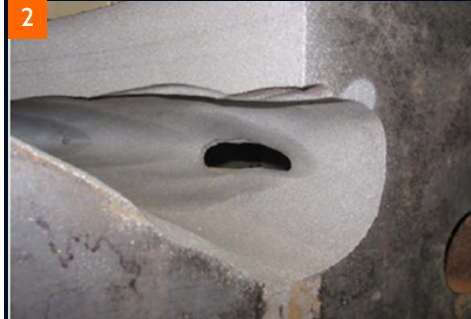
The velocity of the water had led to erosion damage on the end cover of the turbine casing. Several through wall defects were reducing the efficiency of the unit. The end cover was 2.6m wide, 0.2m deep and 1.4 m long

1. One of the end cover halves (there are 4 in total)
2. View of the end cover after surface preparation. Through wall defects clearly visible
3. A former was used to create the original profiles
4. The application of Belzona 1341 to complete the repair
