# REPAIR AND PROTECTION OF FOUNDRY SAND MIXERS WITH BELZONA

ID: 3428

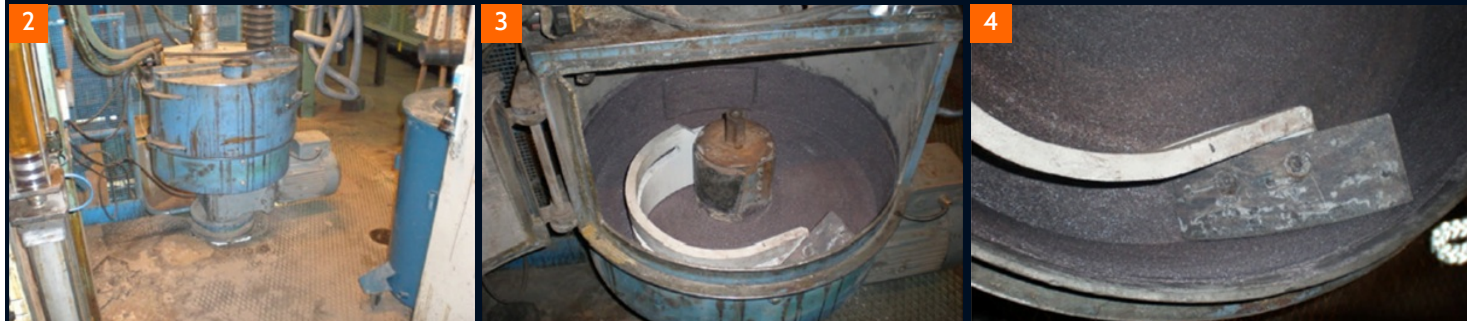
## PHOTOS

Severe wear on the bottom as well as the lower part of the inside walls/sides where the mixer arm passes and scrape along the sides.

1. The damaged sand mixer
2. An overview of the sand mixer
3. After the finished application of Belzona 1812
4. An applicator mounted on the mixer arm to achieve the required profile

Application was carried out in accordance with Belzona System Leaflet SHM-13. Belzona 1812 was used to repair and protect the exposed surfaces. The rotating mixer arm was used to make sure the bottom and the lower parts of the sides in the mixer were even and correct clearances achieved.
