# THORDON BEARING GLUED IN PLACE WITH BELZONA

ID: 3429

Replacement of one of the main turbine bearings.

Hydro power station, Sweden

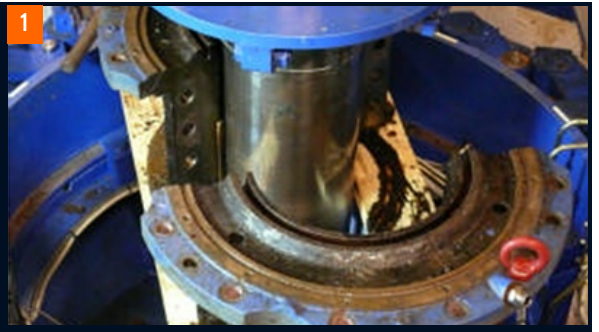
1. Dismantling the bearing housing on the turbine
2. The damaged bearing had disbonded from the bearing housing which resulted in a corroded surface
3. Thordon SXL bearing half mounted and glued with Belzona 1321. Clamps are used to hold bearing in position

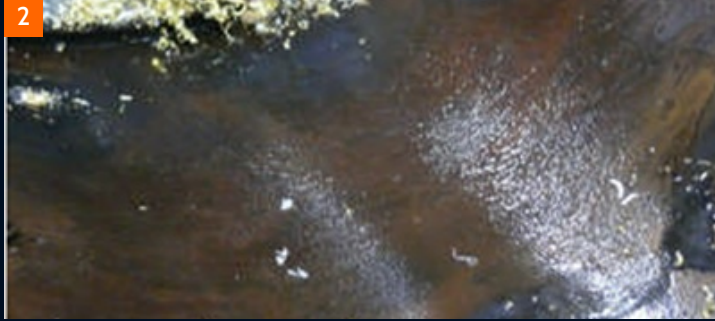
The original bearing was worn out and in need of replacement. The client was looking for effective solution to bond the bearing in place.

Application was carried out using a modified version of Belzona Know-How System Leaflet SHM-7. After grit blasting the bearing housing, Belzona® 1321 was applied to the bearing housing and Thordon SXL bearing before clamping into place until cured. Finally, the bearing was machined down to the correct inner diameter.
