# SEVERE EROSION IS NO MATCH FOR BELZONA

ID: 343

End suction pump for sugar liquor.

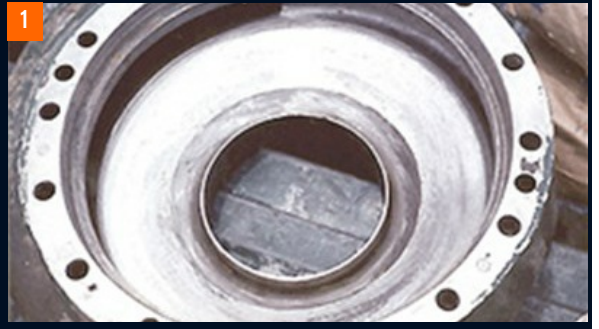
The sugar liquor pump housing near the impeller had suffered from severe erosion and exhibited extensive metal loss.

1. Housing demonstrating extensive wear
2. A template was used to restore the original profile
3. Housing rebuilt to the original profile and coated to handle high temperature service

The application was carried out in accordance with a modified version of Belzona Know-How System Leaflets CEP-3 and CEP-5. A fixture was used to rebuild the extensive metal loss and maintain tolerances with the impeller.
