# PROTECTION OF DISTRICT HEATING SYSTEM

ID: 3430

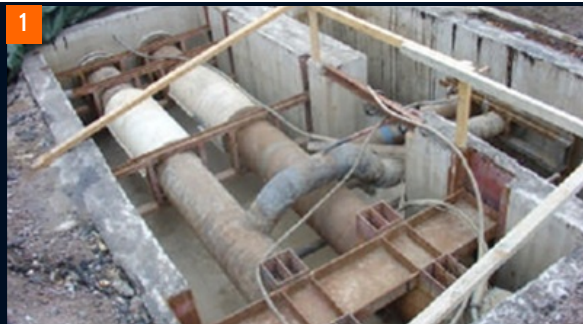
Corrosion on feed and return pipes as well as on supporting steelwork. System is in continuous use so products capable of application to hot surfaces required.

1. District heating Chamber before renovation
2. Dry ice blasting
3. Coating being applied
4. The finished application
