# FRANCIS TURBINE SHAFT PROTECTED WITH BELZONA

ID: 3431

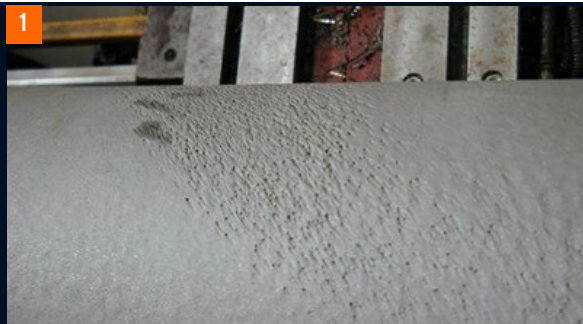
Shaft damaged by cavitation and erosion

1. Shaft damaged by cavitation/erosion
2. Belzona 2141 after the application
3. Inspection of Belzona 2141 protection of the turbine shaft after 9 months in service.

After blasting the surface, Belzona® 1341 was applied in one coat. Belzona® 2941 conditioner was used to tie in the Belzona® 2141 system.
