# HIGH SPEED PATROL BOAT STABILIZED WITH BELZONA

ID: 344

Stabilizer from a MK-5 High Speed Patrol Boat.

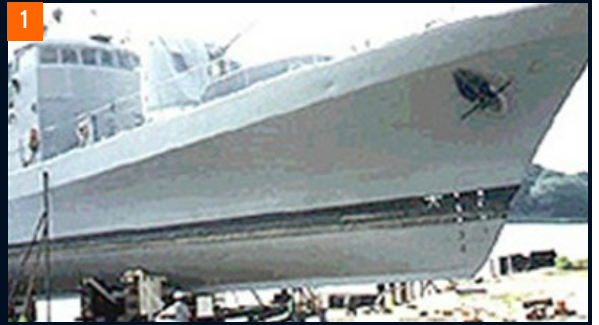
1. High speed patrol vessel
2. Cavitation damage to stabilizer trailing edge
3. Rebuilding cavitation damage
4. Both stabilizers completely rebuilt and coated

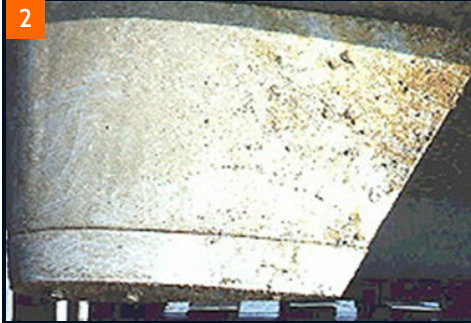
Much like a rudder, cavitation damage will manifest itself on the areas of greatest pressure differential. In this case, entrained solids and cavitation caused metal damage to the trailing edge of the patrol boat's two stabilizers.

You can TIG/MIG weld aluminum, however this process is both expensive and time consuming. In addition, you risk introducing dissimilar metals during this uncontrolled heat treatment process. This particular vessel is on a constant state of readiness and the dock time is limited to an as needed basis.
