# 600 M2 FLAT ROOF WATERPROOFED WITH BELZONA

Leaking 600 m2 flat roof

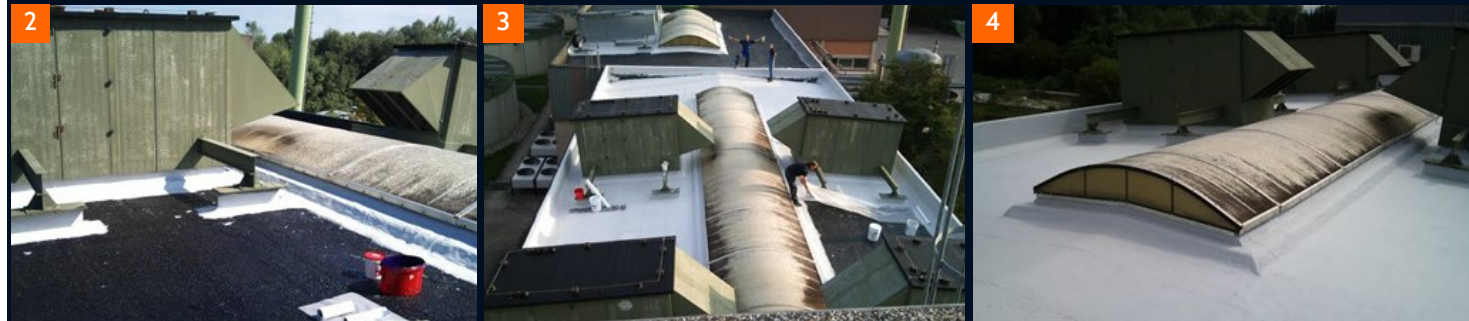
## PHOTOS

Melt water had regularly leaked through the roof into the hall below as a result of the snow-prone winters in this region.

1. Damaged roofing substrate
2. Application to detailed areas
3. Application in progress
4. Completed application

Application carried out in accordance with Belzona Know-How System Leaflets RPA-1, 6, 7 & 8.

The application took only 3 days to complete. Despite the harsh and snowy winter of 2010/2011, the roof is still completely watertight today and the customer is very satisfied with the result. In contrast to commonly used weatherproofing materials, the cold applied, microporous Belzona system allowed for seamless encapsulation of the roof, adapting to the complex, irregular roof contours as well as roof movements.
