# BELZONA KEEPS THIS PASSENGER FERRY RUNNING SMOOTHLY

Rudder horn of large ferry vessel.

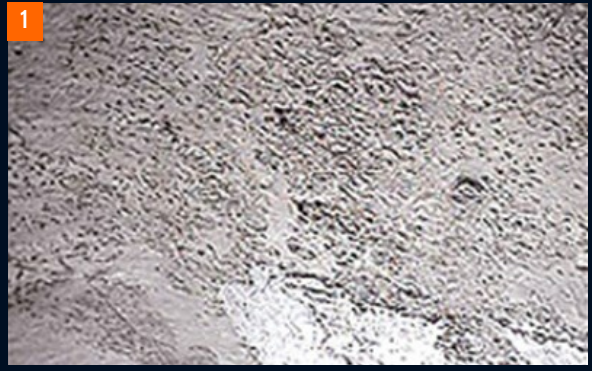
The sides and trailing surfaces of this large rudder horn suffered from cavitation and significant metal loss.

1. Cavitation clearly evident
2. Rebuilding with Belzona 1121 (Super XL-Metal)
3. Belzona 2141 being applied
4. Final application
