# BELZONA REPAIRS AND PROTECTS A PUMP TRANSPORTING 98% SULFURIC ACID

ID: 346

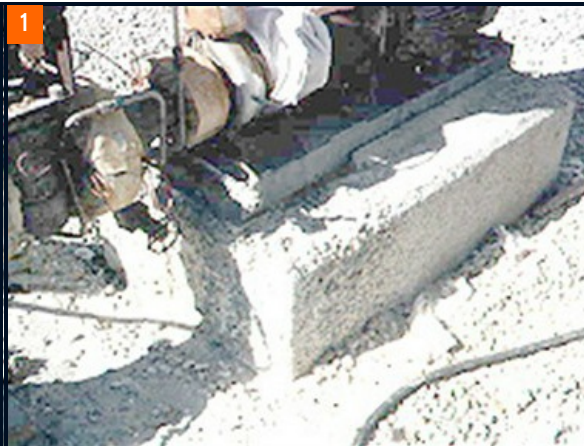
A pump carrying 98% sulfuric acid was leaking, causing severe deterioration of the concrete base, pump stand and the surrounding containment area.

1. Deteriorated pump base and containment area
2. Rebuilding with Belzona 4131 (Magma Screed)
3. Coating with Belzona 4311 for finished application
