# BELZONA SEALS CRACKS IN UNDERWATER CONCRETE TANK

ID: 349

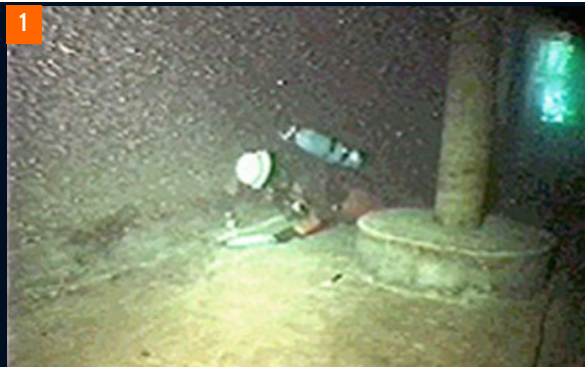
1. Diver sent down to begin the application
2. Diver utilizing a putty knife to force Belzona 4111 (Magma Quartz) into concrete cracks
3. Large section of spalled concrete repaired

The aquaduct could not be drained so the only alternative was to do an underwater application. The slurry version of the Belzona ® 4111 (Magma Quartz) can easily wet out the concrete and even though adhesion is reduced, the repair was still a success.

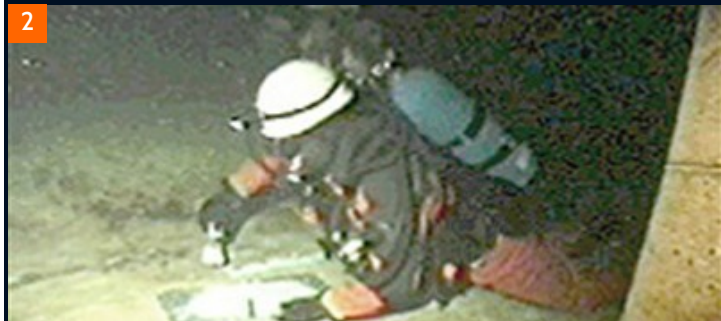
Concrete cracks in base of aquaduct.
