# BELZONA RESTORES OFFICE FACADE

ID: 3491

Concrete cladding panels on office building

Commercial offices, Sheffield, UK

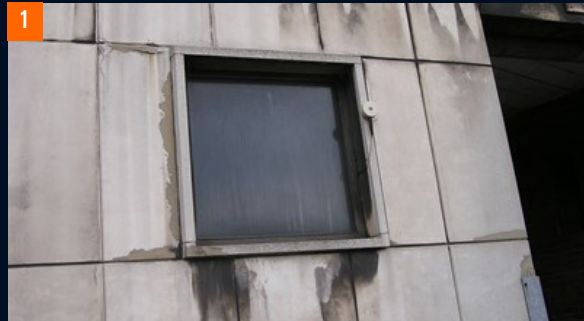
Concrete Panels on the lower section of the building had chipped, spalled and aesthetically degraded over time due to dirt and environmental contaminant staining. Panels surrounding the upper windows had suffered similar damage

1. Staining of concrete panels with initial small Belzona 4141 repairs around the window
2. Lower concrete panels during application of Belzona 4141
3. Lower sections of the building restored and protected with Belzona 5151
4. Finished application

The application was carried out in accordance with Belzona Know-How System Leaflets WPA-1 and WPA-4. All damaged concrete surfaces were rebuilt using Belzona® 4141 before being overcoated with Belzona® 5151.
