# BELZONA BOAT LIFT TIRE REPAIR

ID: 35

Drydock boat lift tire

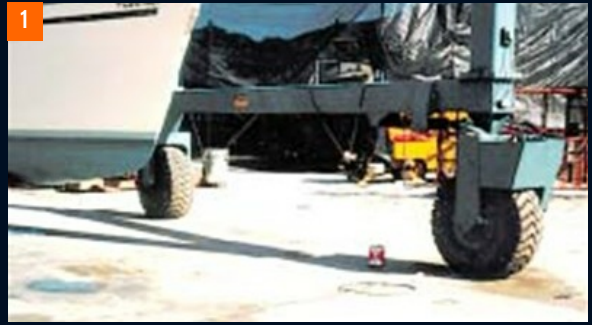
1. View of boat lift used to hoist vessels from water
2. Tire tread is separating from the tire
3. Tire repaired with Belzona 2311

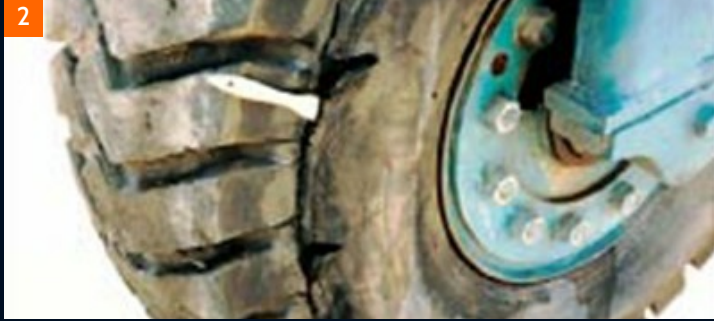
Tires on lift are actually retreaded aircraft tires. Delamination of the tire tread due to use and exposure to the sun.

Tires cost approximately \$1,000 each. Two units of Belzona® 2311 (SR Elastomer) were used to repair the damaged area and to protect the tire from future deterioration. More importantly, it improved the reliability of the boat lift. If the machine is down, this company could be out of business.
