# BELZONA ENHANCES THIS COAST GUARD CUTTER

ID: 351

110' Island Class Patrol boat rudder and stabilizer.

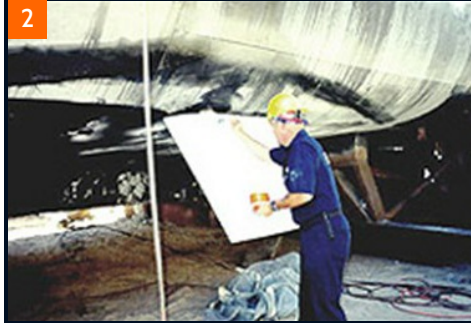
1. View of the 110' class cutter
2. Application of Belzona 1341 to stabilizers
3. Rudders coated
4. Completed application and equipment installed

All the stabilizer work was done in place. Two coats of Belzona ® 1341 (Supermetalgilde) were applied and allowed to sufficiently cure. A small crane was then brought in and the equipment was then installed. Belzona ® 1341 (Supermetalgilde) works well as long as the crew follows a regular cleaning procedure by periodically removing marine growth.
