# BELZONA STOPS CORROSION ON THIS 5,000,000 GALLON TANK

ID: 352

A five million gallon fresh water holding tank.

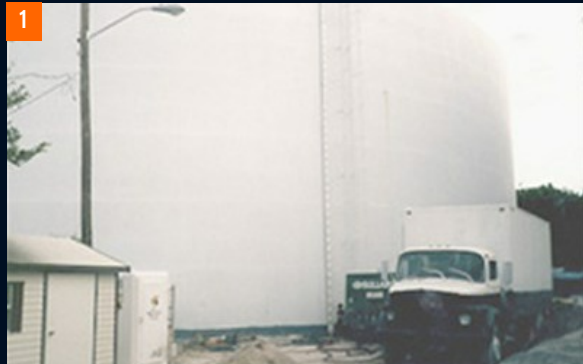
Concrete holding pad settles. Rain water penetrates space between metal tank and concrete pad. Stagnant water causes corrosion.

1. General view of the application site
2. Following surface prep, concrete pad and metal are conditioned
3. Application of first coat of Belzona 3111 with Belzona 9311 (Membrane reinforcement sheet)
