# BELZONA PROVIDES EROSION/CORROSION PROTECTION TO THIS POTABLE WATER TANK

ID: 353

Potable water holding tank at power plant.

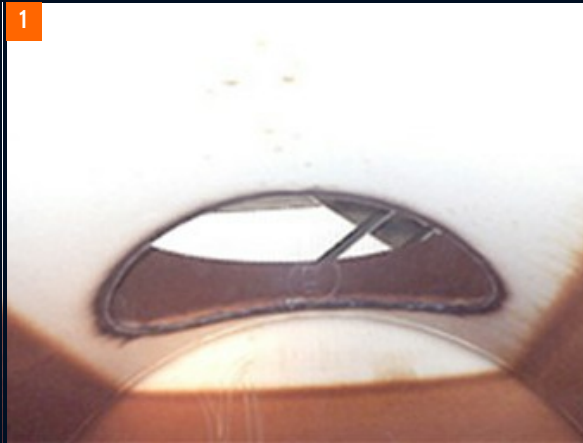
Erosion-corrosion and blistering of original coating.

The original tank coating failed after three years as a result of cold wall blistering. Belzona ® 1341 (Supermetalgilde) NSF was used for erosion/corrosion protection. The product is certified to ANSI/NSF Standard 61 as acceptable for use in contact with drinking water.

1. Internal view of the tank with corrosion evident
2. First coat of Belzona 1341 (Supermetalgilde)
3. Application of Belzona 1341 (supermetalgilde) complete
4. Outside of tank coated with Belzona 6111 and Belzona 5111
