# BELZONA STOPS DAMAGE FROM OCCURRING AT NEW LOADING DOCK

ID: 354

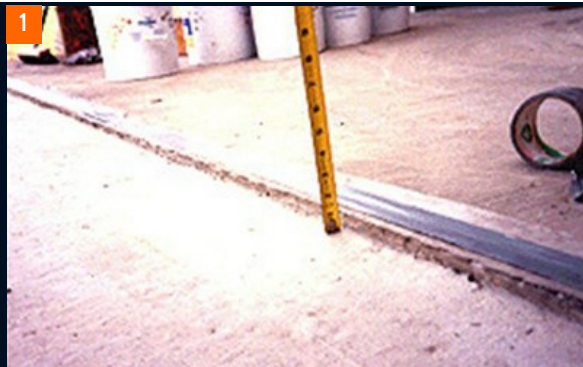
1. The recessed area of the dock
2. The area taped and conditioned
3. Belzona 4111 (Magma Quartz) trowelled into place

As this was new construction, a recess two feet wide and one quarter inch deep was left the entire length of the 20-foot long loading dock. After the concrete was fully cured, this area was cleaned and prepared with Belzona® 4911 (TX Conditioner). Belzona® 4111 (Magma Quartz) was then trowelled into place at the edge of the dock. The application was carried out based on the company's previous experience with Belzona.
