# BELZONA SAVES RETIREMENT RESIDENCE OVER \$7,000

ID: 355

Rooftop exhaust fan shroud.

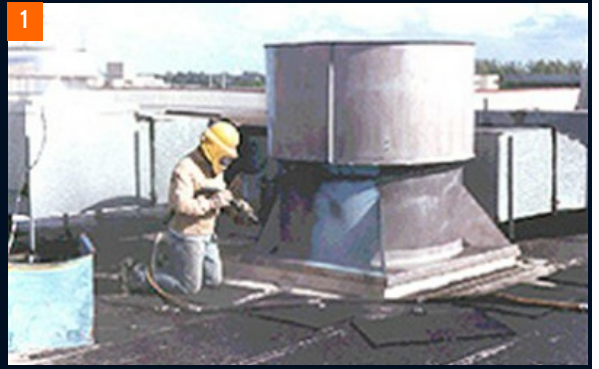
A six foot diameter exhaust fan is used in case of a fire to evacuate smoke from the burning building. The corroded metal shroud developed holes. Rainwater entered through the holes and caused water damage to the inside of the building.

1. Shroud grit blasted
2. Completed coating with Belzona 5111 (Ceramic Cladding)

The application was carried out in accordance with a Belzona Know-How System Leaflets FBC-2 and FBC-4.

Belzona 1111 (Super Metal)  
Belzona 6111 (Liquid Anode)  
Belzona 5111 (Ceramic Cladding)
